CULTURAL LANDSCAPE REPORT
FOR THE SANDY HOOK
COASTAL DEFENSE BATTERIES
GATEWAY NATIONAL RECREATION AREA

CULTURAL LANDSCAPE REPORT FOR THE SANDY HOOK COASTAL DEFENSE BATTERIES

GATEWAY NATIONAL RECREATION AREA

FORT HANCOCK, NEW JERSEY

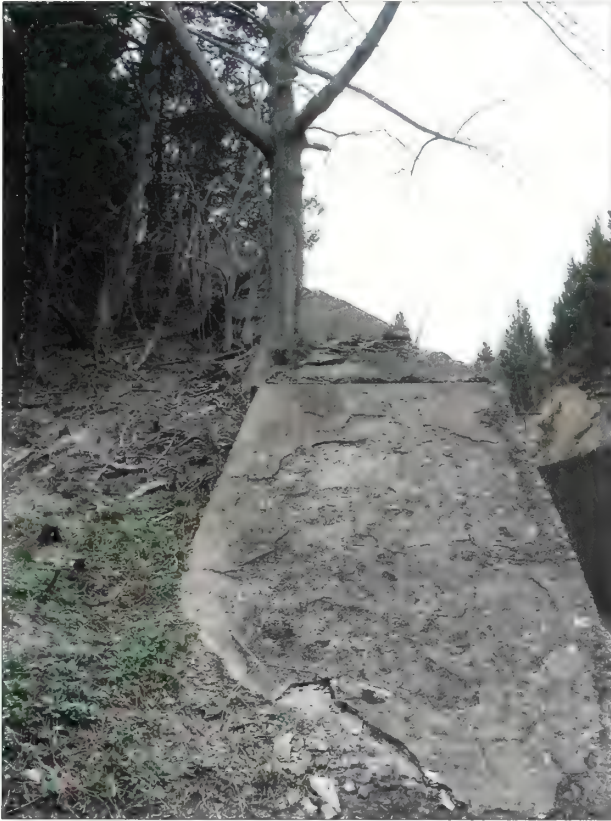
Concrete surfaces at the Mortar Battery exhibit spalling areas and cracks resulting from water infiltration and freeze-thaw cycles (see Figure 5.75). In order to limit further damage to the concrete, spalling surfaces should be removed, mechanically cleaned, and patched to match the character of the historic material. Small cracks should be dried and prepared to receive a sealant that is compatible with the character of the historic concrete. The treatment of large, structural cracks should be determined by a structural engineer. Additional information addressing the repair of spalling areas and cracks can be found in the treatment tasks common to all battery sites and in the *Historic Fortification Preservation Handbook* (Washington State Parks and Recreation Commission, 2003).

Figure 5.75. View looking southeast at concrete glacis, the Mortar Battery. Here, a tree greater than four-inches in diameter is seen growing directly upon the concrete battery surfaces. Such vegetation must be removed in the interest of long-term preservation of the battery structures (Olmsted Center, April 2008).

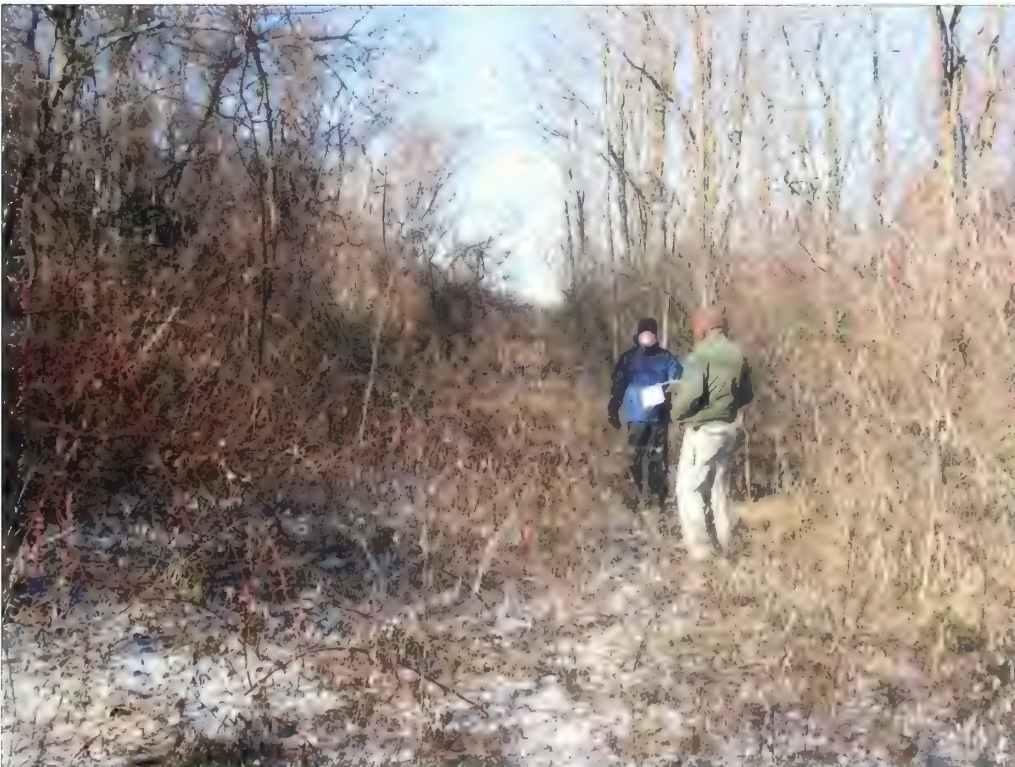
By 1942, an unpaved road was installed north of the Mortar Battery. The road proceeded east from Hudson Road and provided access to temporary structures located north and east of the battery. Presently, the road is almost entirely overtaken by vegetation and is barely passable as a trail (Figure 5.76). In order to rehabilitate a circulation feature from the historic period, vegetation should be cleared from the former access road and an unobstructed, twelve-foot wide route maintained. Woody vegetation should be cut as flush to ground level as possible. Since the trees are not growing on a historic engineered earthwork, the remaining stumps should be ground with a stump grinder to a depth of three inches below grade to minimize potential archeological disturbance. After the woody vegetation has been removed, the twelve-foot width can be easily maintained with a small tractor and brush hog mowing deck. Rehabilitating the access road will aid in accomplishing other treatment tasks at the Mortar Battery by providing an area away from primary circulation routes for vehicles and staging.

Figure 5.76. View looking northwest at trail north of the Mortar Battery. By 1942, an unpaved road was installed north of the Mortar Battery that presently is overtaken by vegetation and is barely passable as a trail. Vegetation should be cleared from this former access road and an unobstructed route maintained (Olmsted Center, January 2009).

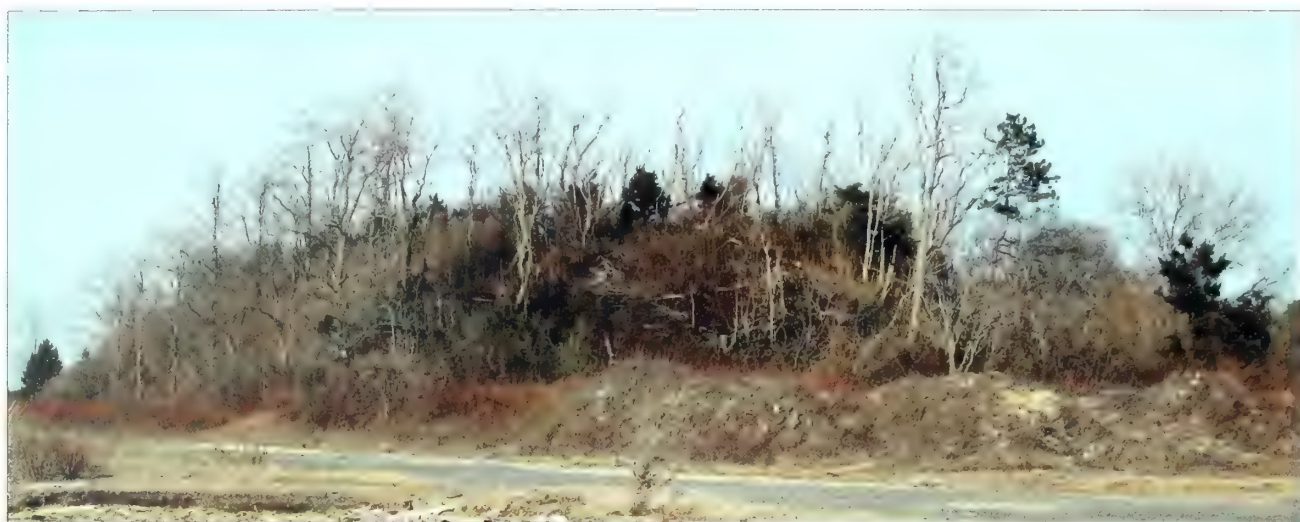
Currently, the most striking feature of the two batteries is their forty-foot tall earthen mounds that rise in stark contrast to the flat, slightly undulating coastal topography around them (Figure 5.81). Large woody vegetation and a thick understory of vines cover the engineered earthen casemates. Above the gun emplacements at batteries Kingman and Mills, concrete canopies were constructed to shield the artillery from overhead fire. The canopies and concrete facades around the emplacement openings show efflorescence and in some cases, large spalling areas. The park has installed a six-foot high chain-link fence above each gun emplacement to prevent unauthorized access to the concrete canopies and injury from a fall.

Figure 5.81. View looking northeast at the Battery Kingman engineered landform. This photograph shows the size and quantity of woody vegetation growing on Battery Kingman's engineered slope. All woody vegetation greater than four-inches diameter at breast height should be selectively removed to preserve the historic structure and its sheltering earthwork (Olmsted Center, January 2009).

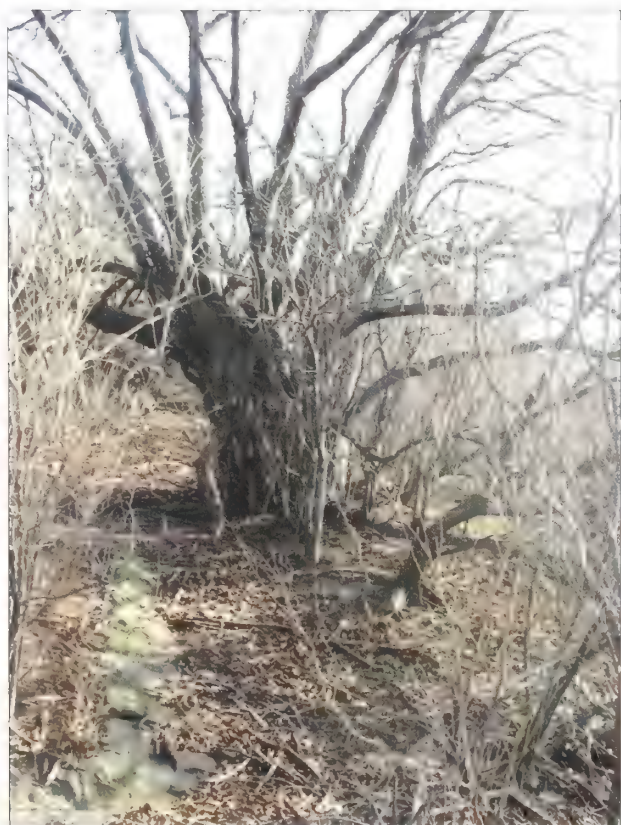
Figure 5.82. View looking south atop of the engineered slope, Battery Kingman. Here, a large tree is seen growing near an exposed concrete feature seen at the left foreground. Woody vegetation should not be permitted to grow on, or within four-feet of concrete battery structures and features (Olmsted Center, January 2009).

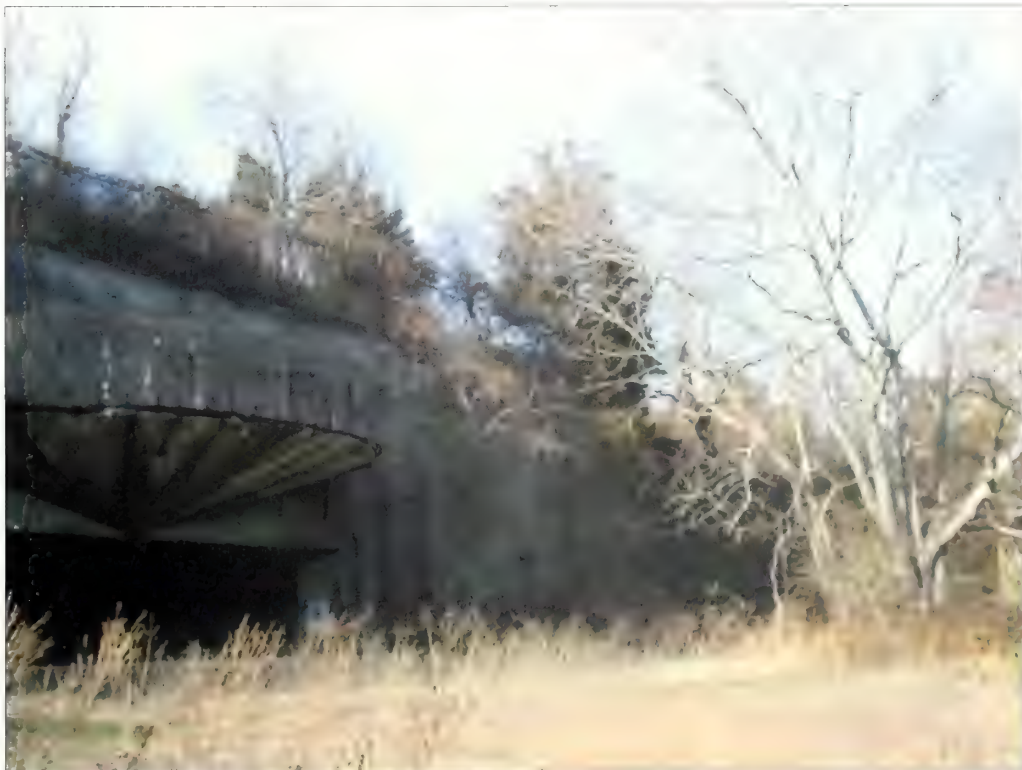
Figure 5.84. View looking northwest at the south gun emplacement, Battery Kingman. Vegetation removal to restore the historic field of fire should focus on the slopes against the battery's concrete facades as the level area in front of the guns is relatively free of tree and shrub vegetation (Olmsted Center, January 2009).

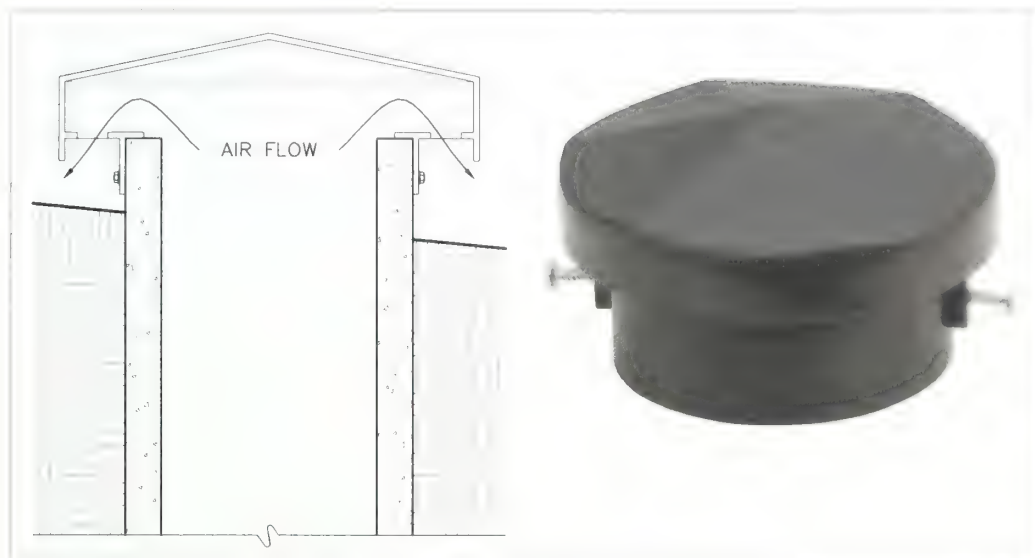
Figure 5.87. Installation of cap over concrete pipe and ABS plastic ventilation cap. The top of the cap should be pitched to prevent water and ice from building up. It should also be vented to allow air flow (Olmsted Center and <http://www.toolstation.com/images/library/stock/webbig/22205.jpg>).

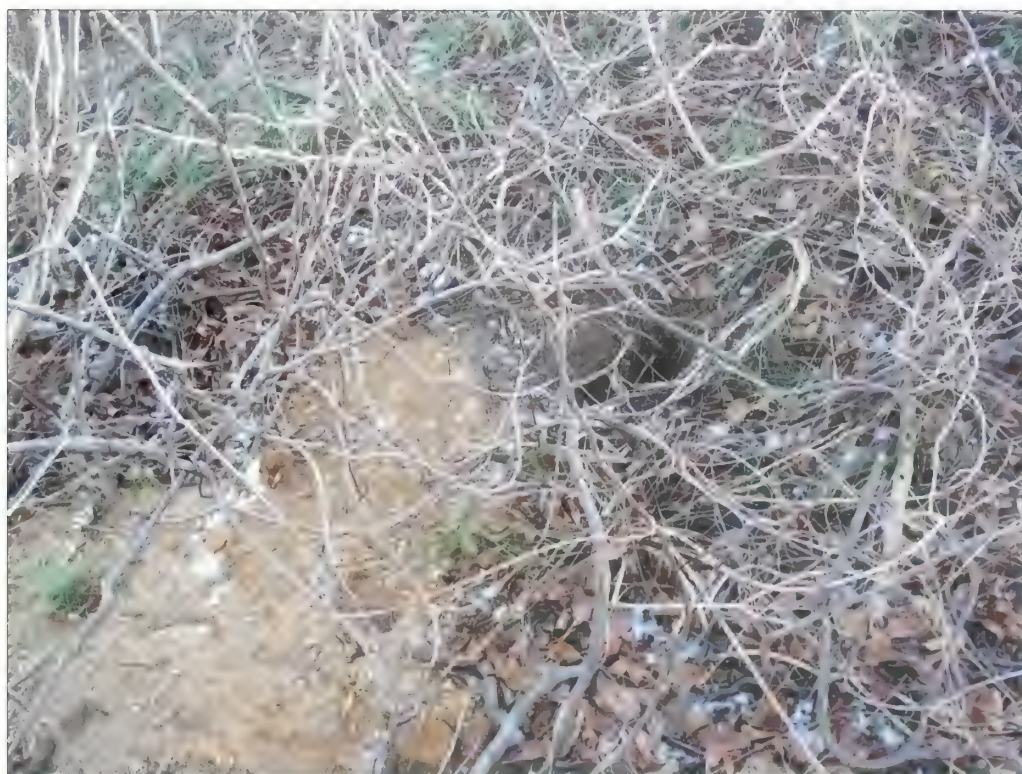
Figure 5.88. Animal burrow on north slope of Battery Kingman. The preferred management recommendation for burrowing animals is to humanely trap the animal and relocate it to an area away from the historic earthwork. The burrow should be filled with soil from a sterile source that does not have the potential to damage archaeological information (Olmsted Center, January 2009).

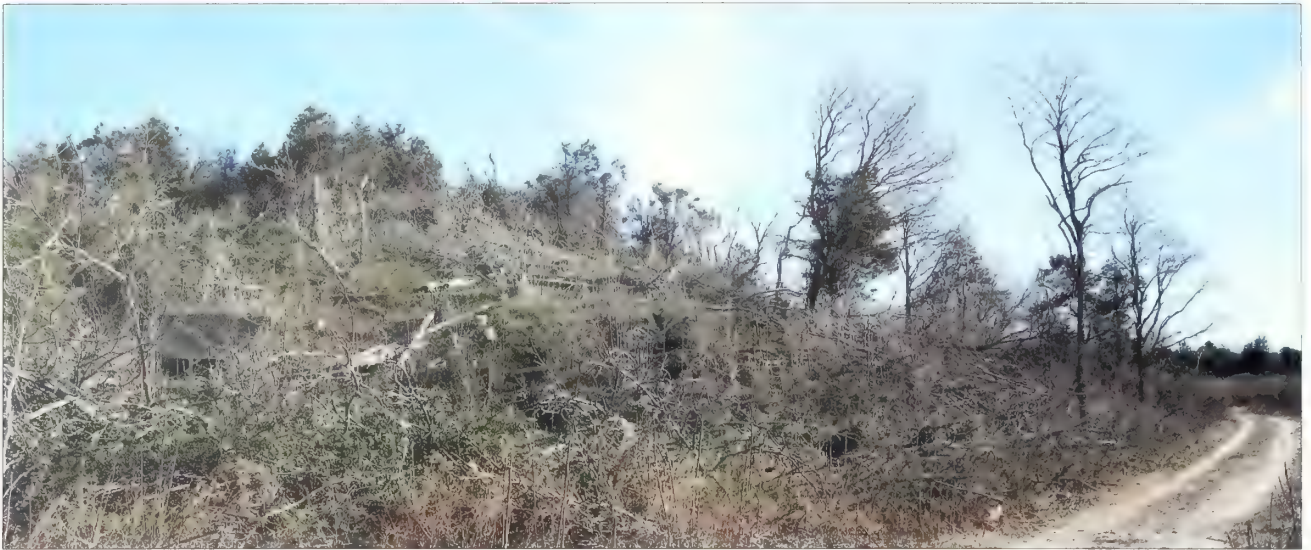
Figure 5.89. View looking east at southern end of Battery Mills. After recent cutting to manage invasive non-indigenous plant species, trunks, limbs, and other fallen debris were not removed. In order to safely and effectively permit future inspections and removals, the trunks and limbs have to be removed (Olmsted Center, January 2009).

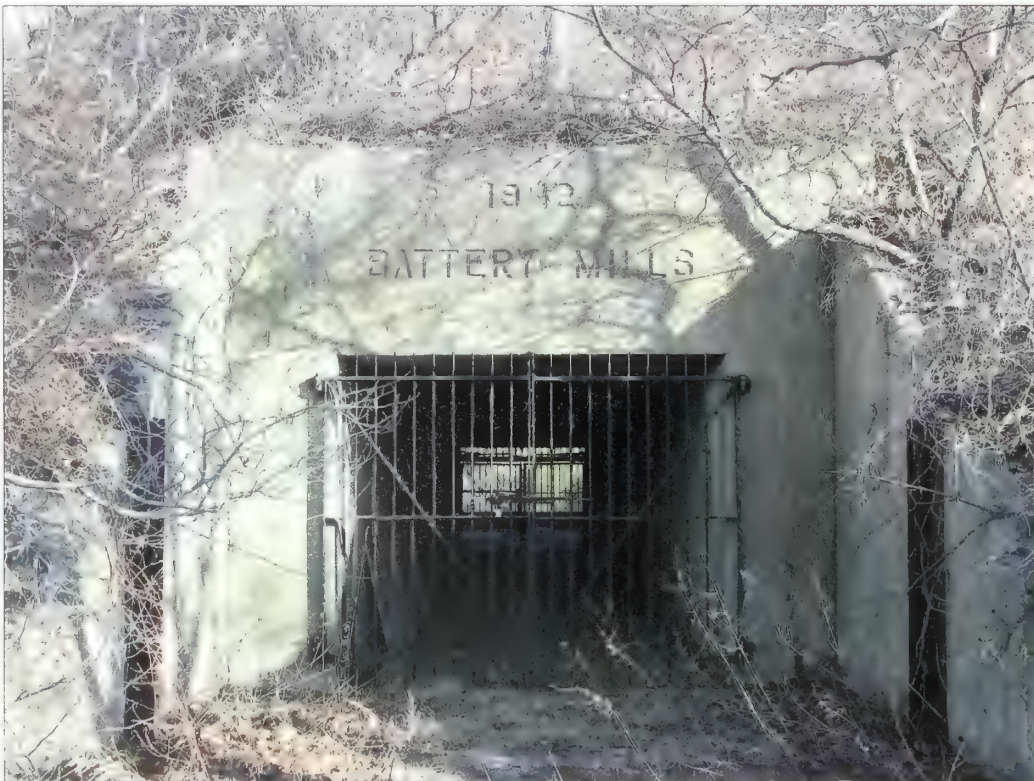
Figure 5.90. View looking east at a bulkhead entry, Battery Mills. All woody vegetation growing on or within four-feet of concrete features like the bulkhead entries should be removed (Olmsted Center, January 2009).

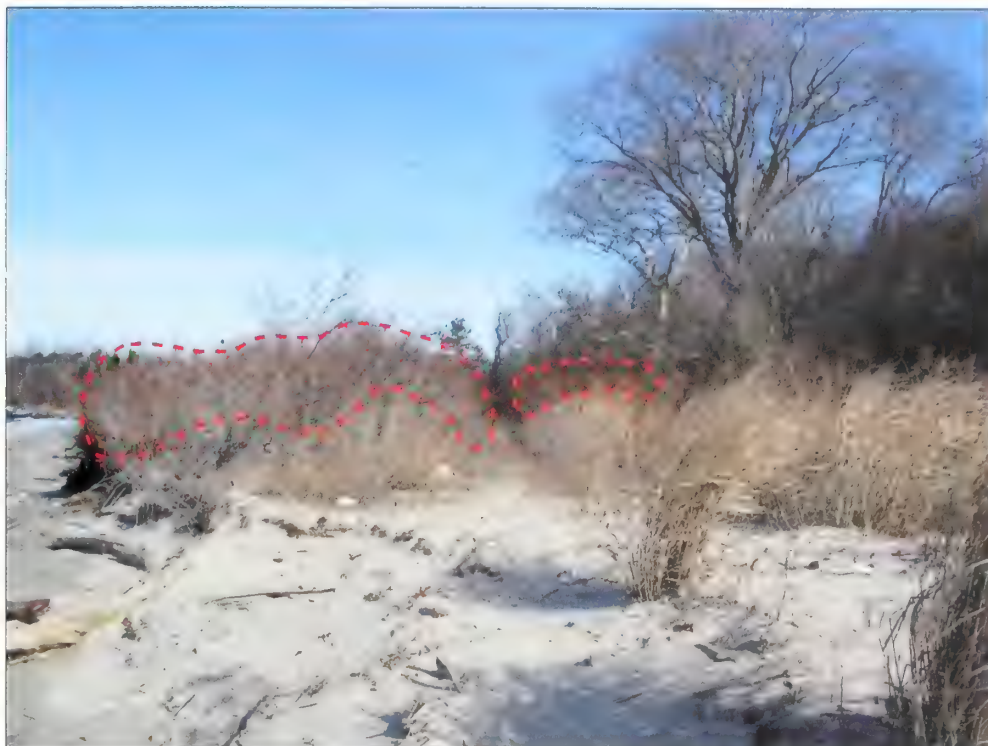
Figure 5.91. Japanese knotweed growing on western side of Battery Mills. The red dashed outline indicates the area of Japanese knotweed in this image. Japanese knotweed has been identified as an invasive non-indigenous plant species by the New Jersey Department of Environmental Protection and should be removed (Olmsted Center, January 2009).

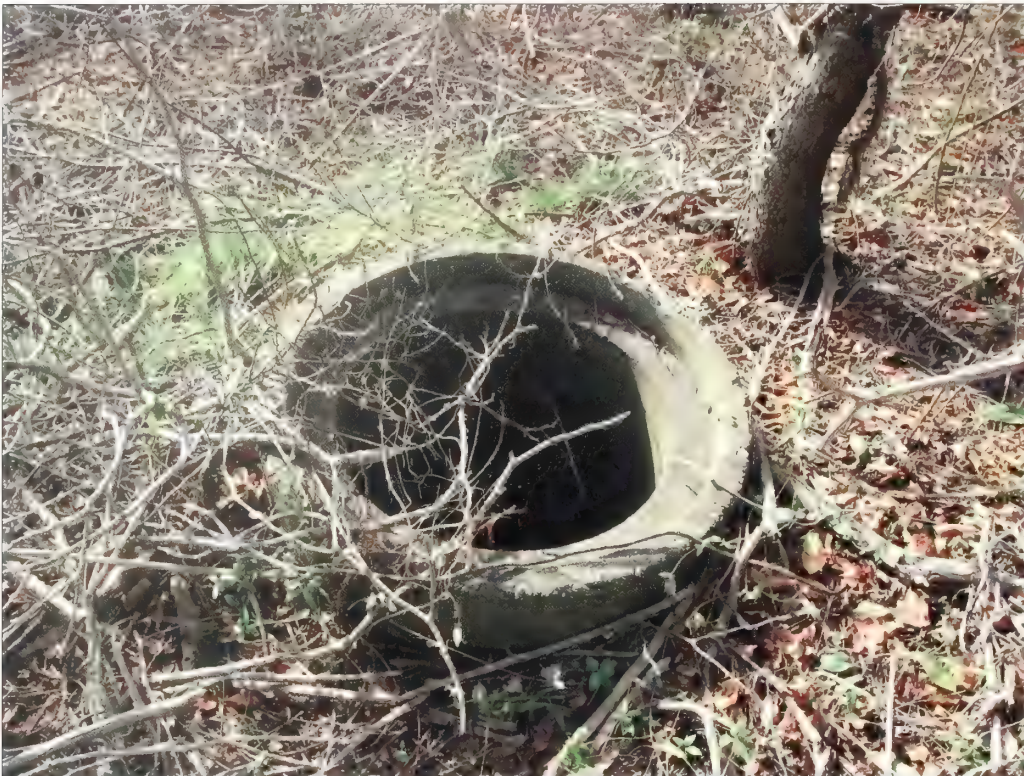
Figure 5.93. Concrete pipe on southern slope of Battery Mills. The concrete pipe should be capped to prevent possible injury and reduce water entering into or around the underground structures (Olmsted Center, January 2009).

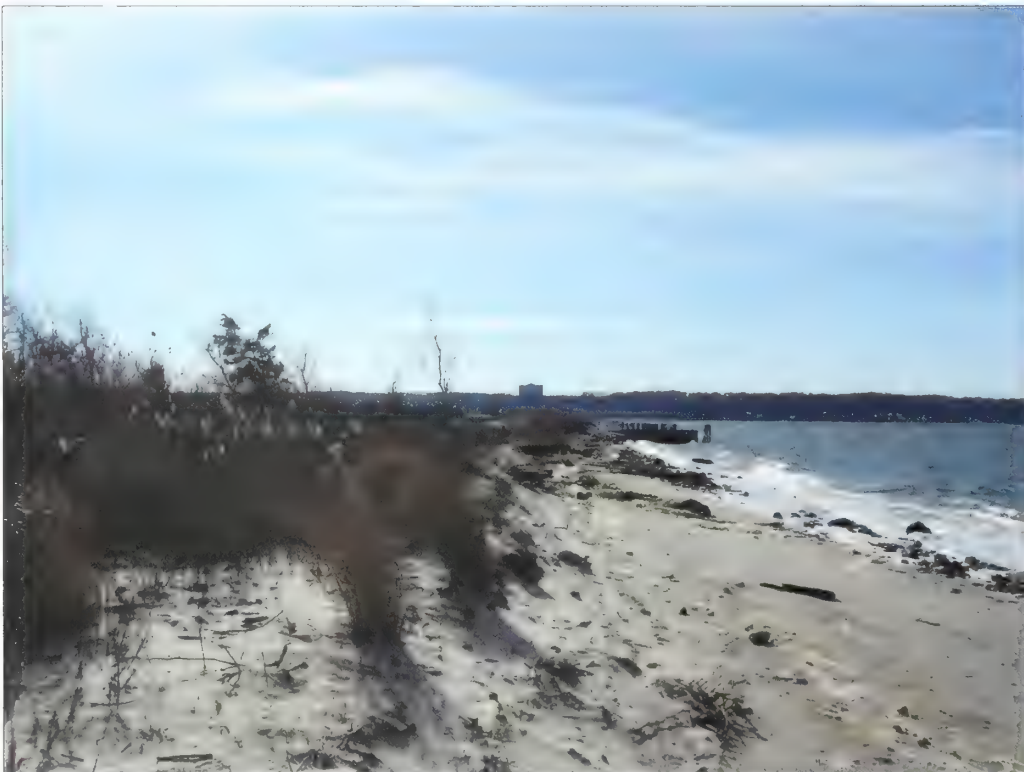
Figure 5.94. Eroded loop road on western side of Battery Mills. To better protect the concrete structures and historic earthworks of Battery Mills, randomly and loosely placed course stones should be installed at the toe of the battery's slope (Olmsted Center, January 2009).

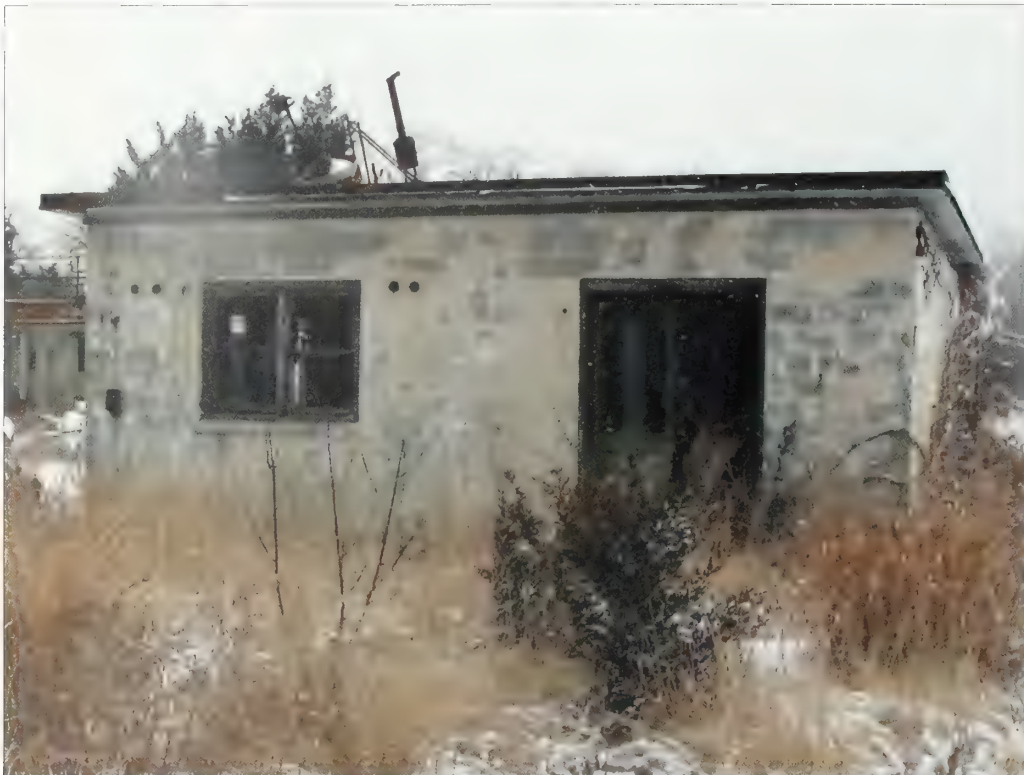
The NIKE radar and launch sites are approximately a mile apart and located off of Hartshorne Drive, Sandy Hook's major north-south thoroughfare. The buildings and structures at both sites show early to intermediate signs of deterioration in specific building materials that include metal, concrete block, and corrugated siding and roofing (Figure 5.98). The radar towers feature guardrails around the tops of their platforms with large openings that would not adequately protect all visitors.

Figure 5.98. View looking southeast at the Generator Building (414), Control Area #1, NIKE radar site. The buildings and structures in the radar site show signs of deterioration in specific building materials that include metal, concrete block, and corrugated siding and roofing. Due to damaged windows and doors, the Generator Building lacks a closed building envelope exposing the interior to water and seasonal temperature fluctuations that advance deterioration (Olmsted Center, January 2009).

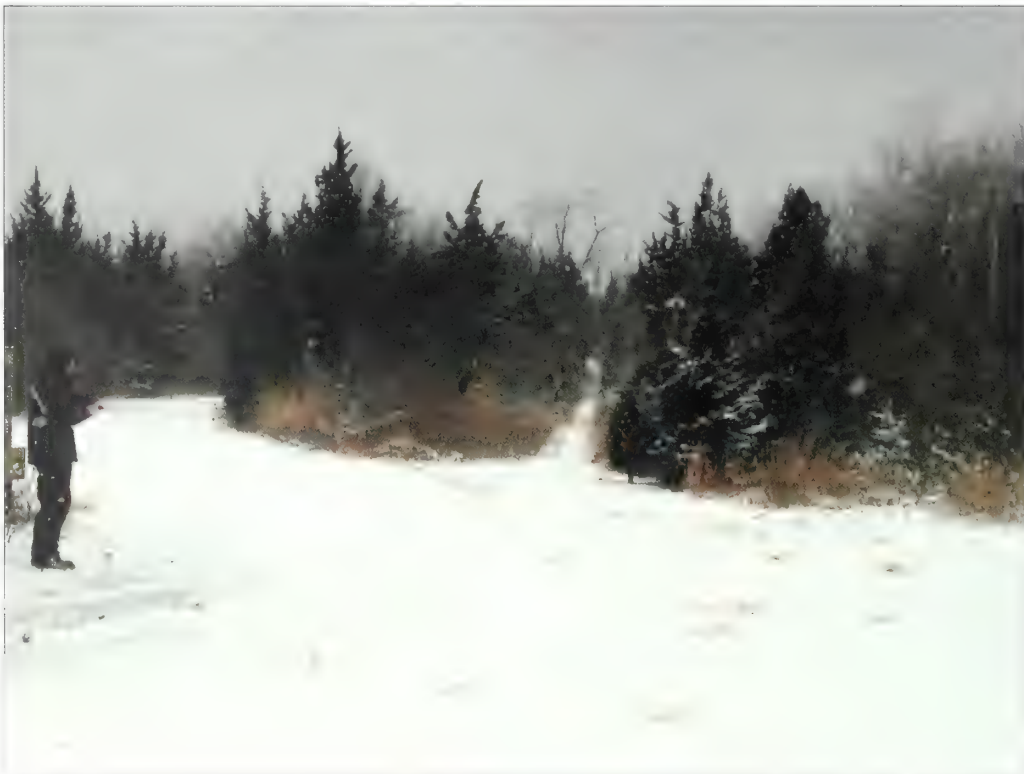
Beginning with deactivation of the sites, woody vegetation has encroached on buildings, vehicular and pedestrian circulation features, and the perimeter fences (Figure 5.99). Large woody vegetation also covers the majority of the engineered earthworks in the launch site (Figure 5.100). The radar site is open to volunteered tours on a regular schedule throughout the year. Tours of the launch site occur three or four times per year. Additionally, the NIKE launch site has become host to a variety of uses including park maintenance and law enforcement, a New Jersey state beach cleaning program, and academic research on weather, tides, and shellfish (Figures 5.101 and 5.102).

Figure 5.99. View looking northwest at pedestrian walkway, Control Area #1, NIKE radar site. Following the site's closure woody species, especially eastern red cedars, have emerged and are encroaching on pedestrian circulation features as well as buildings and the perimeter fence (Olmsted Center, January 2009).

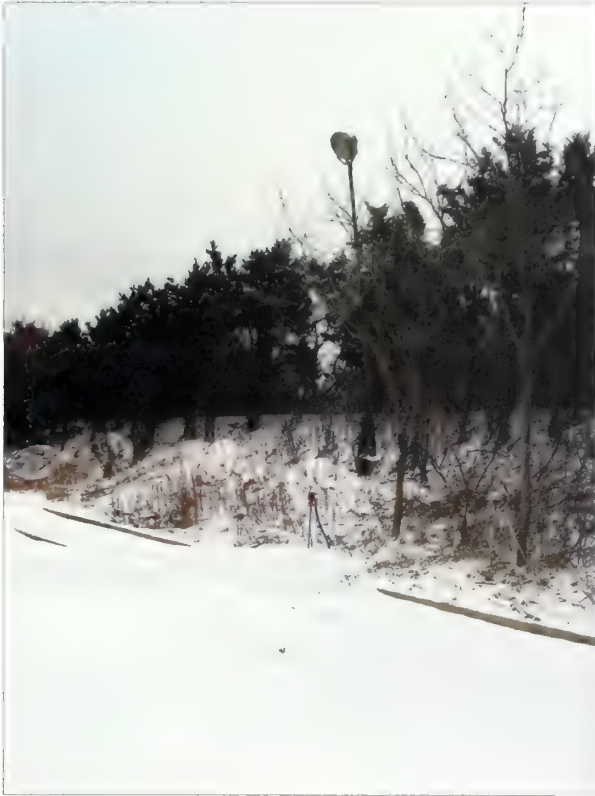
Figure 5.100. View looking southeast at engineered earthwork, NIKE launch site. Eastern red cedars (*Juniperus virginiana*) cover the majority of the engineered earthworks in the Missile Maintenance Area (Olmsted Center, January 2009).

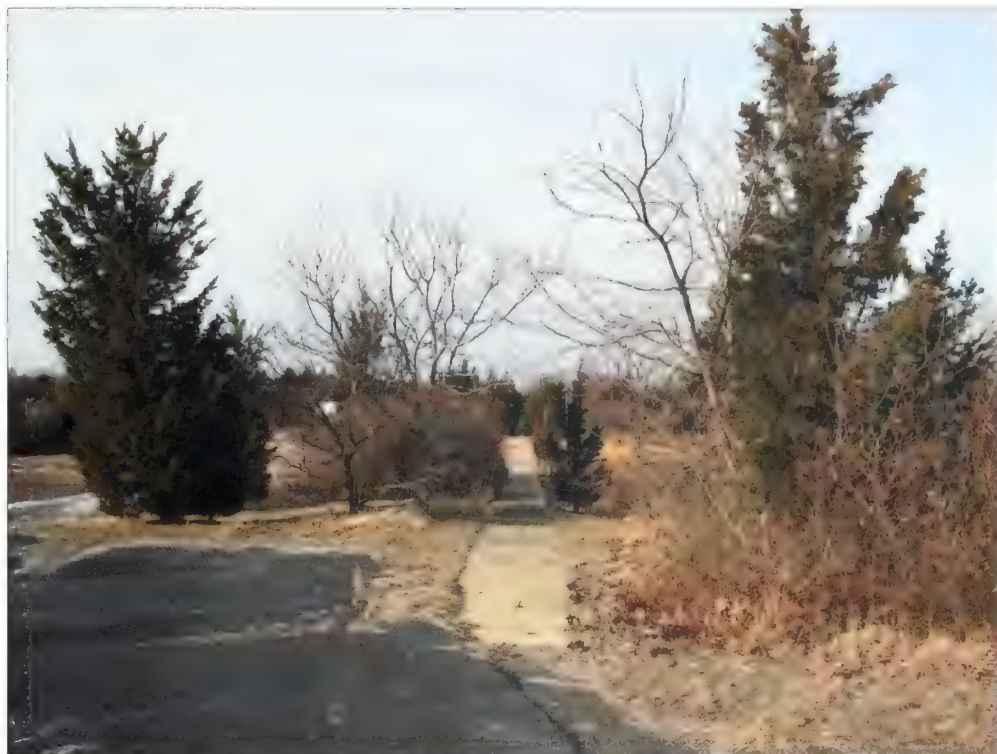
Figure 5.104. View looking north of sidewalk from Control Area #2 to the Ready Barracks, NIKE radar site. Asphalt, concrete, and gravel-surfaced circulation features should be cleared of woody vegetation six-feet off of all sides. Once woody vegetation, like the eastern red cedars seen in this photograph, has been removed, the six foot width can be easily maintained with a small tractor and brush hog mowing deck (Olmsted Center, January 2009).

The park has recently removed some vegetation to reveal the historic sidewalks that once provided access between the control areas and the Ready Barracks. Further removal of woody vegetation is needed to protect the circulation features from future incursions. Asphalt and concrete-paved circulation features, as well as gravel-surfaced features, should have vegetation cleared a minimum of six-feet off of all sides of the feature (Figure 5.104). Large woody vegetation, particularly eastern red cedars (*Juniperus virginiana*), should be removed first. Once the large woody vegetation has been removed, the six foot width can be easily maintained with a small tractor and brush hog mowing deck.

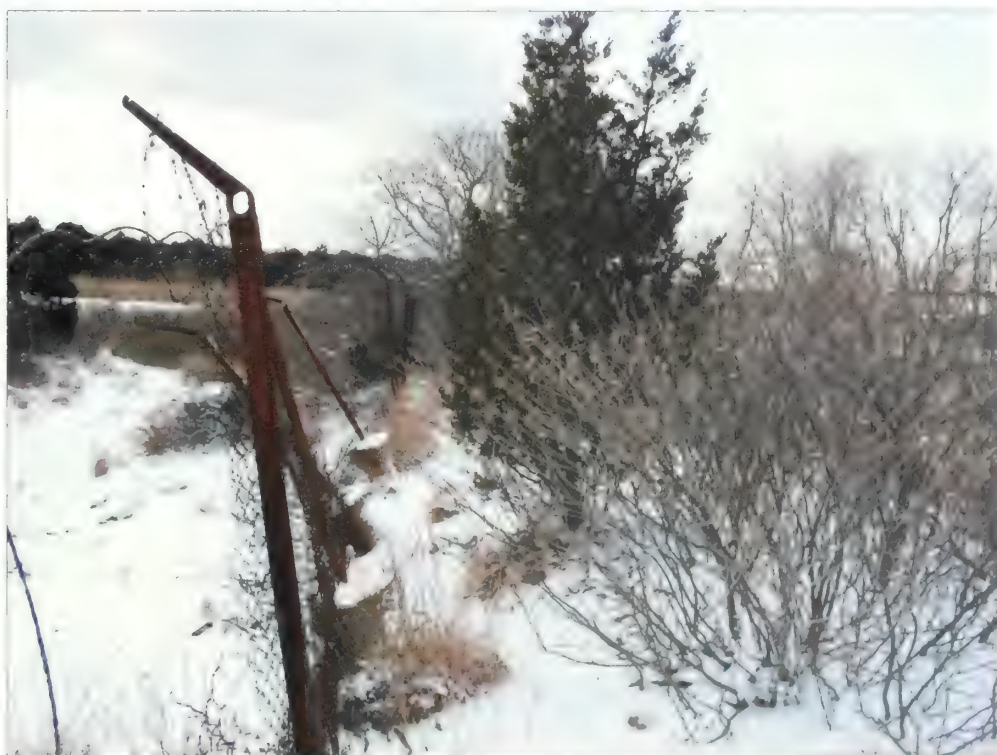
Figure 5.105. Existing perimeter fence, NIKE launch site. The existing perimeter fence at the radar and launch sites should be clearly delineated and maintained by removing all woody vegetation a minimum of four-feet off either side of the fence. The vegetation removals will also aid in inspection and repairs of the existing fence (Olmsted Center, January 2009).

To verify security of the radar area, a site plan from 1954 indicates a fire break thirty-feet inside the perimeter fence. No vegetation was allowed to grow within this thirty-foot zone for security as well as fire prevention. Restoring the thirty-foot fire break is not practical and would create additional maintenance workload, however, the fence line and historic boundary of the site should be clearly delineated and maintained by removing all woody vegetation a minimum of four-feet off either side of the perimeter fence (Figure 5.105 and Drawing 5.11).

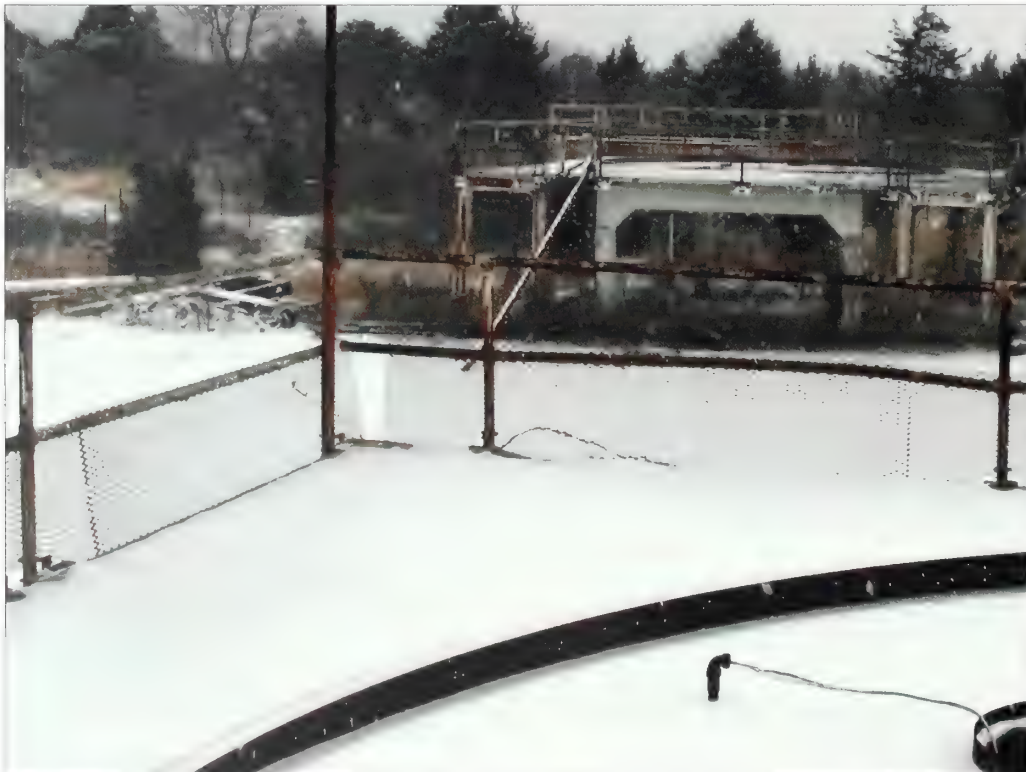
Figure 5.107. Existing expanded metal mesh on guardrails at radar tower, NIKE radar site. New expanded metal mesh should match the existing in this photograph and be applied to the lower and upper openings of the existing guardrails for added safety (Olmsted Center, January 2009).

To provide a higher level of protection, expanded metal mesh should cover the existing guardrail openings. On other radar platforms, expanded metal mesh is present at the lower level of the guardrail (Figure 5.107). The metal gauge and mesh spacing should match the existing sample. The new infill material should cover lower and upper guardrail openings and be attached to the inside of the rails with non-corrosive hardware. The clamps would permit easy replacement or removal and minimize damage to the guardrails.

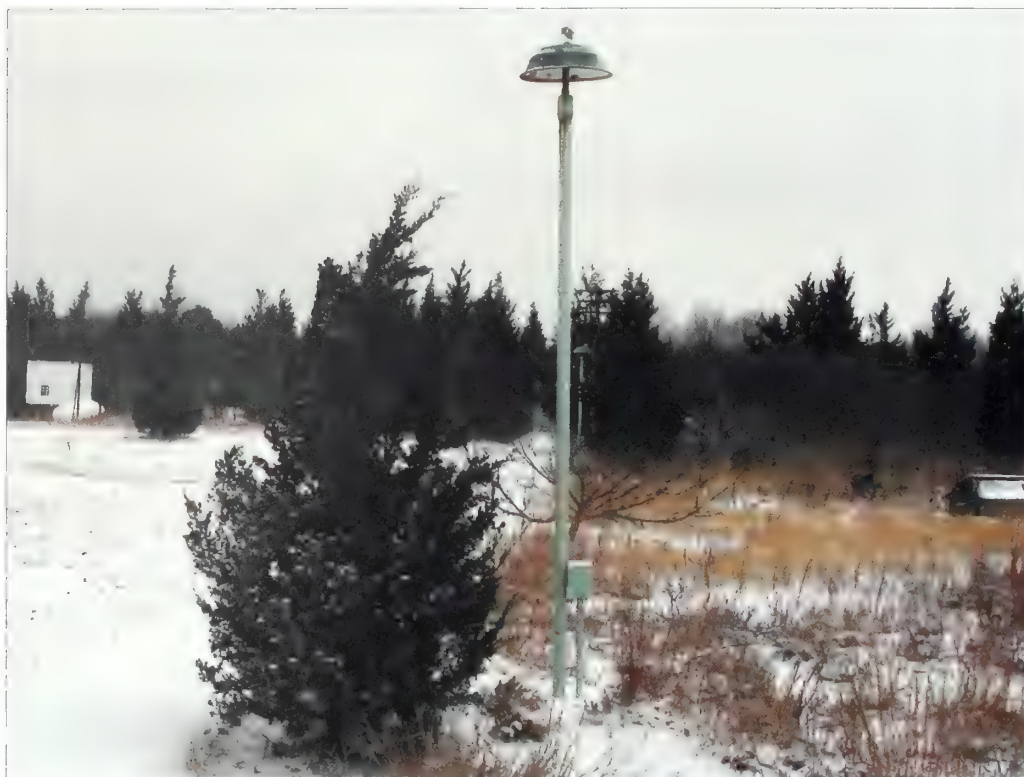
Two sidewalks provided pedestrian access from the Ready Barracks to Control Area #1 and #2. Along these walks simple light fixtures—comprised of a tubular pole and metal reflector—were installed. The majority of light fixtures are in good to fair condition and should be periodically assessed (Figure 5.110).

Figure 5.110. Existing light fixture, NIKE radar site. The historic light fixtures should be periodically inspected, have components repaired or replaced as needed, and receive corrosion treatment, priming, and painting to match the historic finish. The eastern red cedar in the foreground should be removed as part of vegetation management along the circulation systems (Olmsted Center, January 2009).

Damaged or severely deteriorated components should be replaced. If necessary, new hardware and connectors should be fabricated to match the existing if a contemporary supplier cannot be found. Corrosion on the metal components should be removed or made inert with a chemical treatment and immediately followed with priming and painting to match the historic finish.

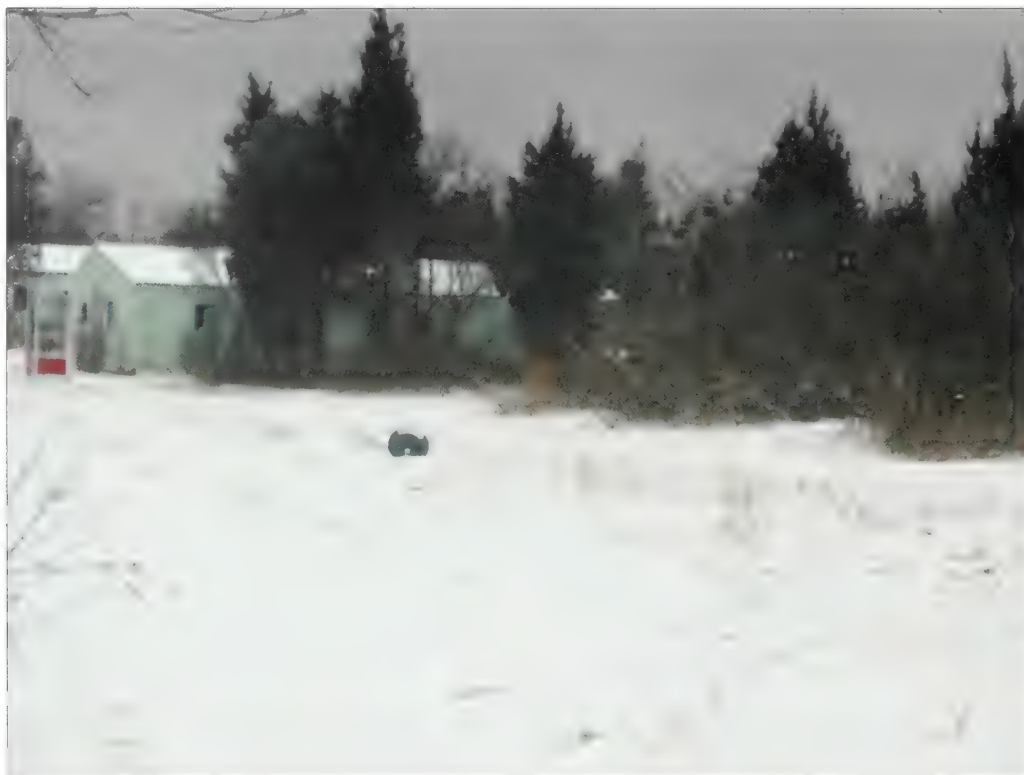
Figure 5.111. Existing light fixture between building 404 and 405, NIKE radar site. The fallen fixture should be reset and will most likely require a new concrete footing and tubular pole. The new pole should match the existing in material, dimensions, and finishing. The fixture's other components should be inspected at this time and repaired or replaced based on their condition (Olmsted Center, January 2009).

The light fixture should be reset and will most likely require a new concrete footing to accomplish this task. Due to snowy conditions, it was difficult to determine at what point the fixture failed and fell over. Resetting the fixture may require a new tubular pole with adequate length to extend into the footing below ground. The new pole should match the existing in material, dimensions, and finishing. The fixture's other components should be inspected at this time and repaired or replaced based on their condition.

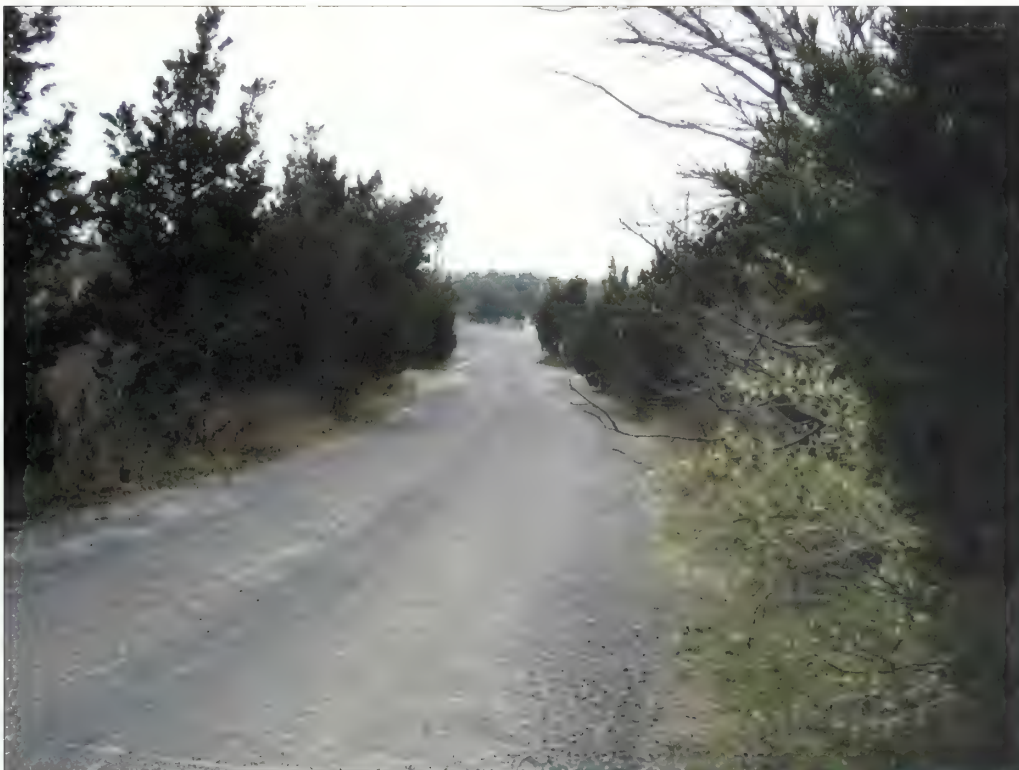
Figure 5.113. View looking northwest toward Ready Barracks, NIKE launch site. This photograph shows the vehicular route has become overgrown and feels like a tight corridor in contrast to the open, low-growing vegetation in the historic image. The overgrown vegetation limits vehicular sight-distances and may put pedestrians at risk if park visitors use this route as a walkway during the hours of active maintenance operations (Olmsted Center, April 2008).

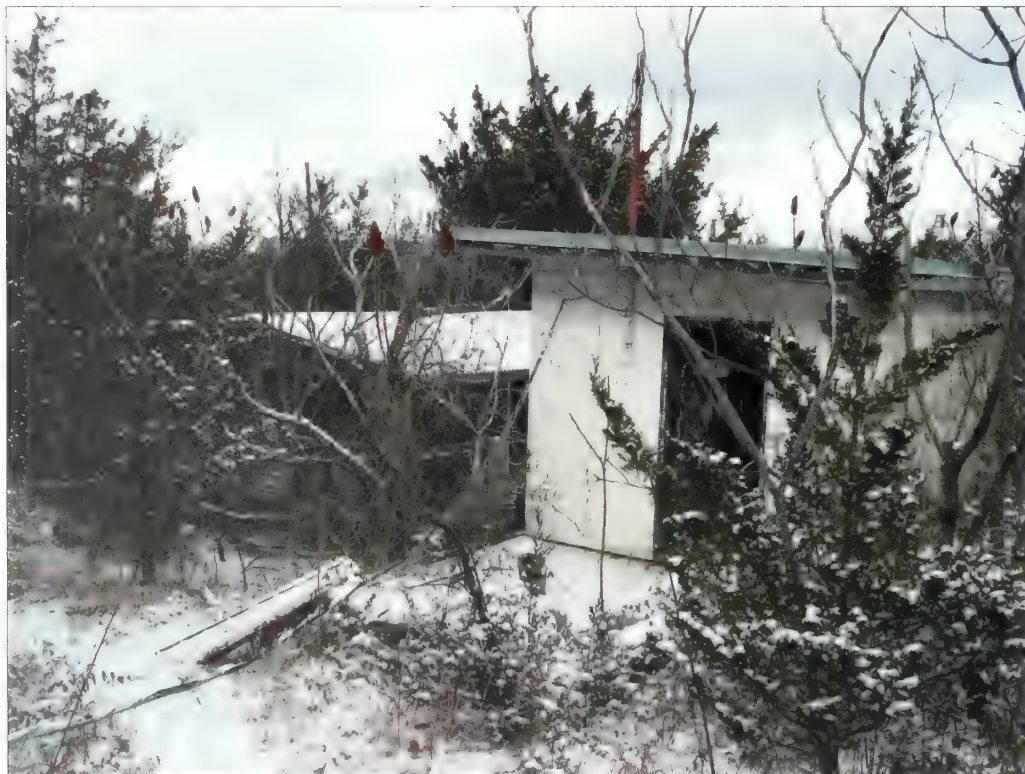
Figure 5.115. View looking northwest at the kennel buildings, NIKÉ launch site. Vegetation removals around existing buildings should focus on the generator building (429) and kennel buildings (457 and 458) as these structures are becoming enveloped by overgrown vegetation (Olmsted Center, January 2009).

The landscape around the Ready Barracks survives in good condition and does not require extensive vegetation removal. In the barracks area, two London planetrees (*Platanus × acerifolia*) are growing in the lawn panels between the buildings and these trees should remain. Historic photographs show that trees were growing in the barrack's lawn panels in contrast to bare earth maintained along other features like fence lines (Figure 5.114). Targeted removals should take place at barracks buildings 430 and 431 were young eastern red cedars (*Juniperus virginiana*) have started to grow near the buildings' foundations. Removal work around buildings should focus on the Generator Building (429) and kennel buildings (457 and 458) as these structures are becoming enveloped by overgrown vegetation (Figure 5.115).

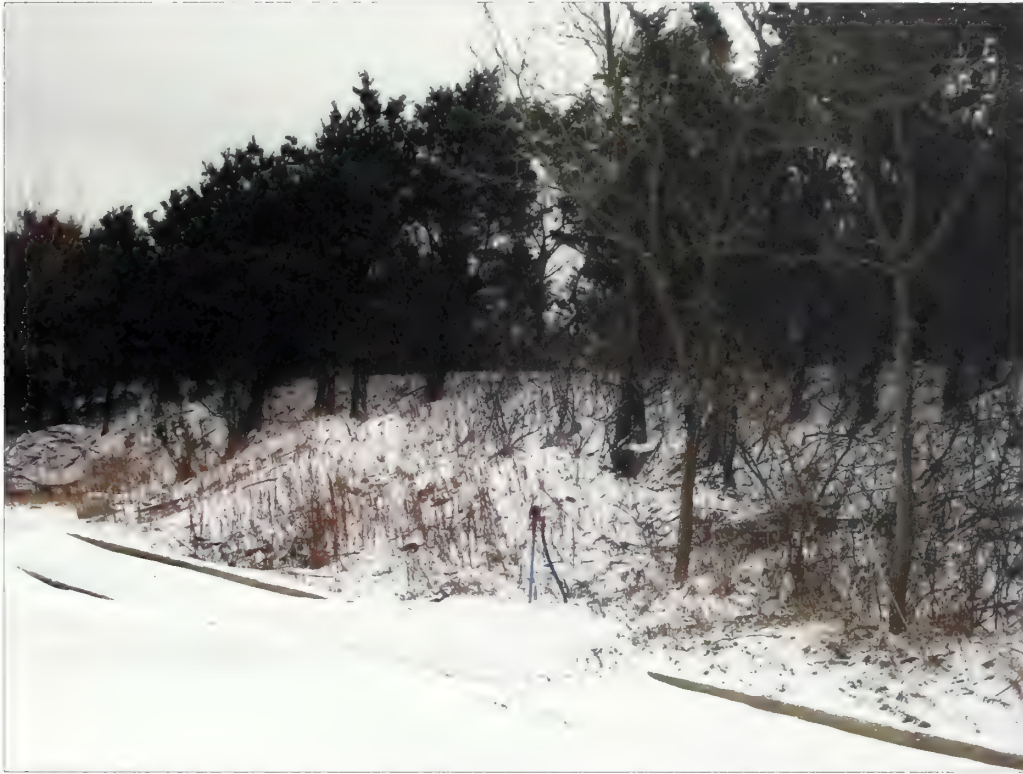
Figure 5.116. View looking southeast at Missile Maintenance Area historic earthwork, NIKE launch site. For the NIKE earthworks, all woody vegetation greater than four-inches diameter at breast height should be selectively removed and the stumps treated with a triclopyr herbicide (Olmsted Center, January 2009).

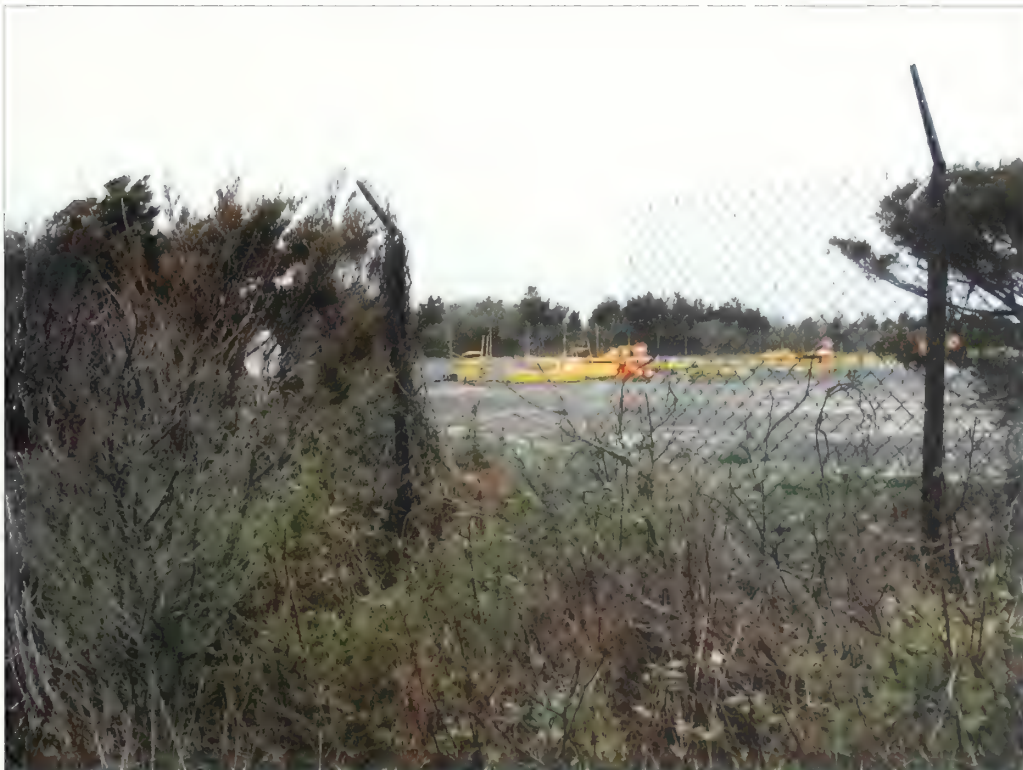
Figure 5.117. View looking east at the missile magazines, NIKE launch site. In contrast to the historic image, extensive vegetation has grown up between the inner fence and perimeter road around the magazines. The dense vegetation will impede repairs to the historic fence (Olmsted Center, April 2008).

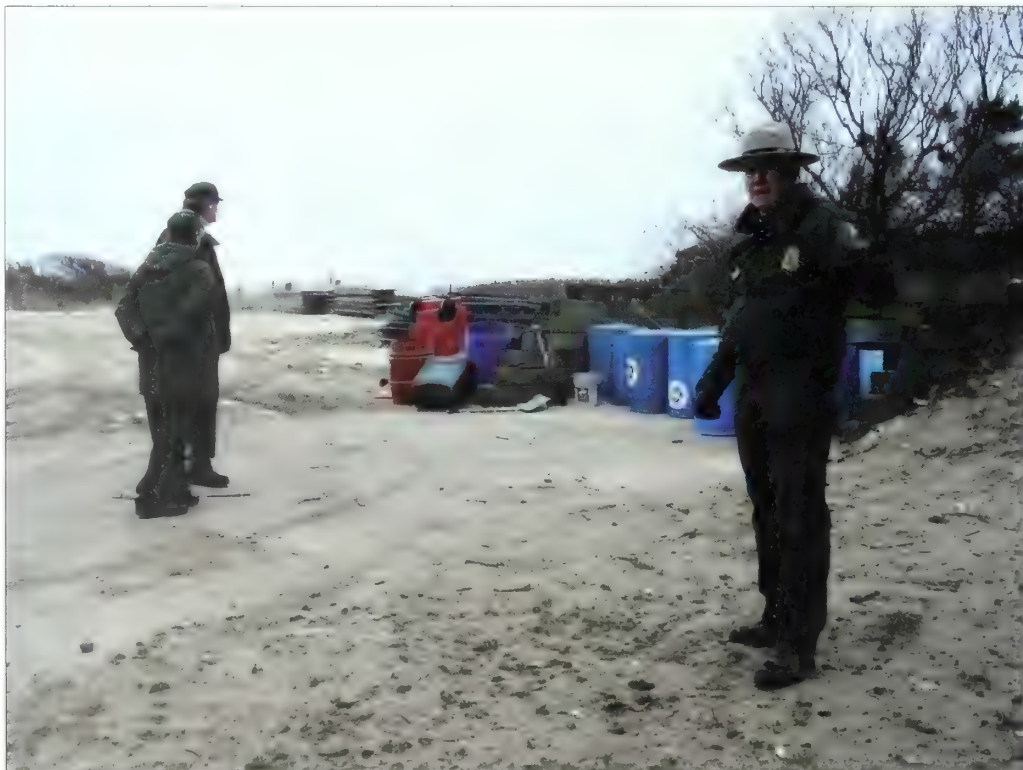
Figure 5.119. View looking east at Missile Maintenance Area historic earthwork, NIKE launch site. The railroad tie retaining structure and recycling containers should be removed from the eastern end of the earthwork (Olmsted Center, April 2008).
